# 5.3 EXISTING SITE CONDITIONS SANTIAGO 7-8 CHARTER MIDDLE

# Orange Unified School District Facilities Master Plan

## **CONDITION ASSESSMENT**

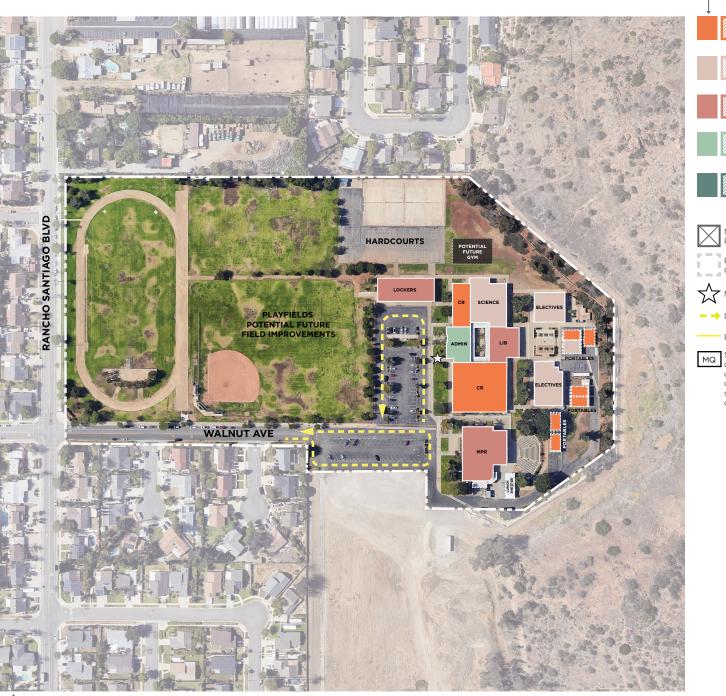
EXISTING SI **7-8**

## English History Resource Specialist Special Day Class Vacant Electives / Labs Science Lab Computer Lab Shared Spaces , Multi-Purpose Room Media Center Locker Room Admin / Faculty
